# International Summer School **PRESERVING HERITAGE: STRATEGIES FOR STABILIZING UNSTABLE SLOPES IN HISTORIC CULTURAL CENTERS**

**Diana Salciarini** –  
[diana.salciarini@unipg.it](mailto:diana.salciarini@unipg.it)  
University of Perugia | Department of  
Civil and Environmental Engineering

# **Case study: The Orvieto cliff**

**Case study: Applied research on hydrogeological risk prevention in the municipality of Deruta**

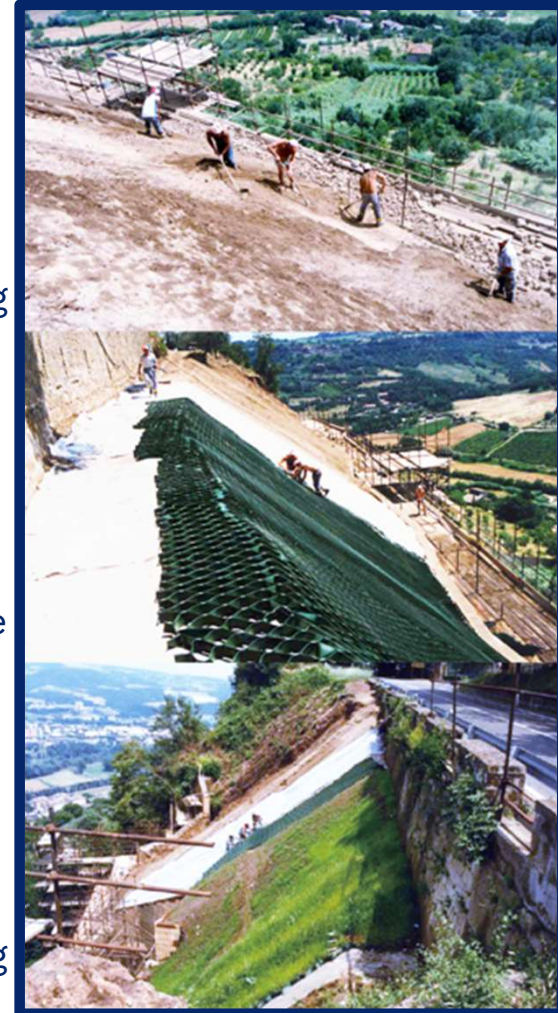
Debris removal and cleaning

Placement of geotextile

Seeding/greening

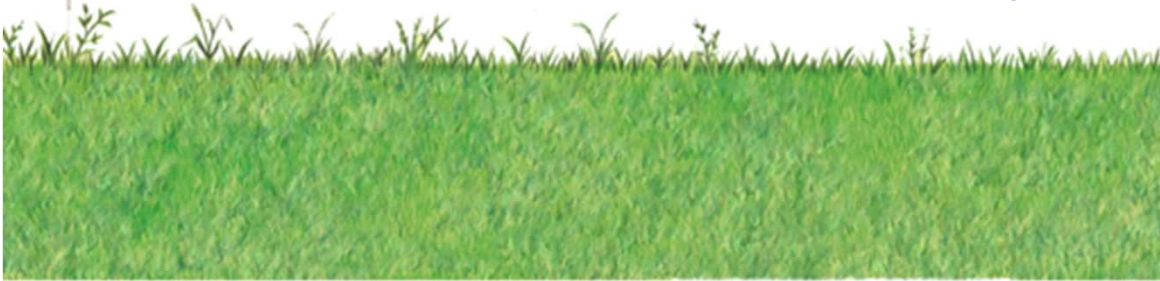
- Grass cover with a **continuous** and **uniform root system**

In both cases, the root system introduces **additional shear resistance** in the upper layers of the soil

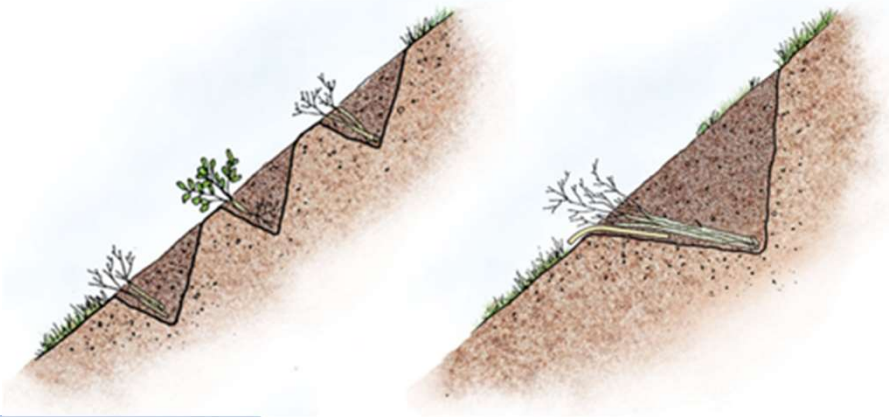
- Shrub cover with a **clump root system**

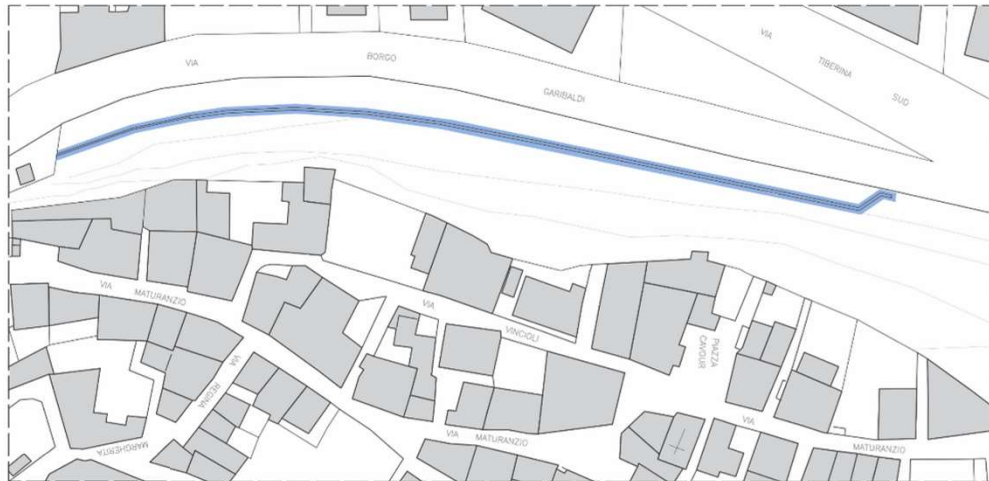
## ZONE 3

Drainage Operation Using Sub-horizontal Drains

### Implementation Phases:

**Drilling:** A hole is drilled using rotation or rotary-percussive methods, with a diameter ranging between 50-100 mm and an upward inclination between 5° and 10°.

**Installation:** Once drilling reaches the design depth, the drilling machinery is removed, and the perforated pipes are installed. PVC pipes with holes ranging from 40-80 mm and thicknesses of 3-6 mm are used. The pipes are covered with geotextiles to prevent clogging of the holes.

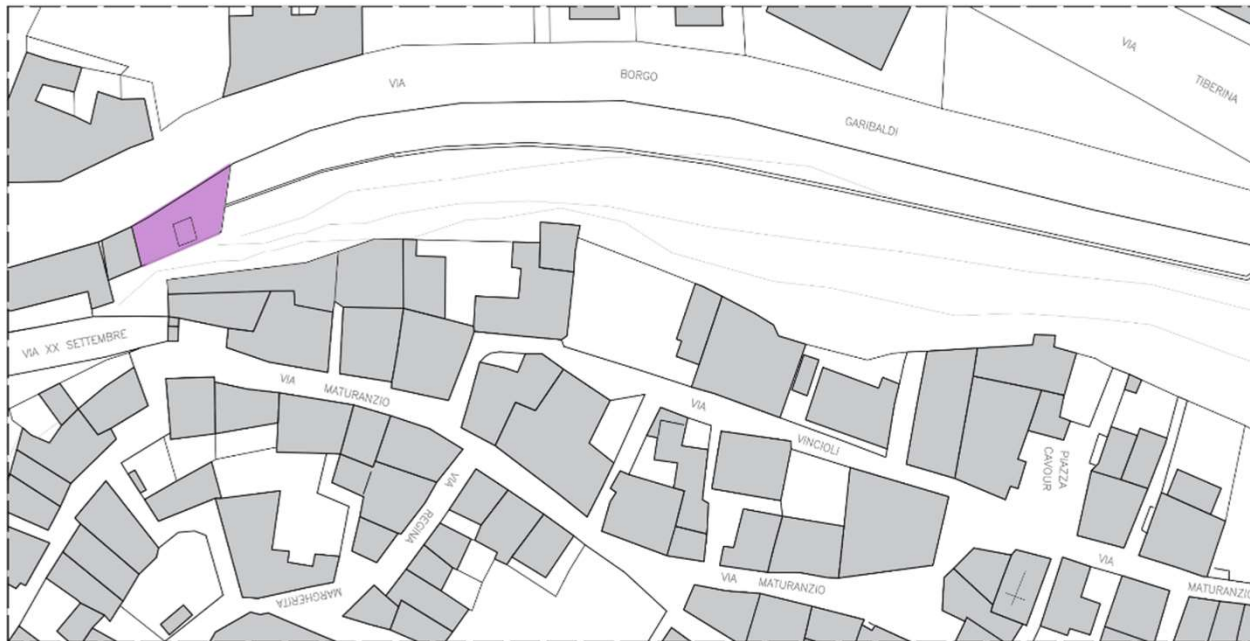
## ZONE 4

In the case of cavities being recovered and reused, it is advisable to implement a new structural system that integrates closely with the existing rock surface. The cause of collapse phenomena within the cavity is the lack of a system that effectively supports the overlying loads. For these reasons, a geomechanical analysis of the rock mass should be carried out to correctly design a structural support using timber or steel props.

For areas with existing masonry surfaces, reinforcement and consolidation can be achieved by applying an intradosal cladding with a mesh made of natural fibers and stainless steel, followed by the application of finishing mortars. As an alternative to the distributed system, which allows for even load redistribution, transverse and longitudinal band systems can be used.

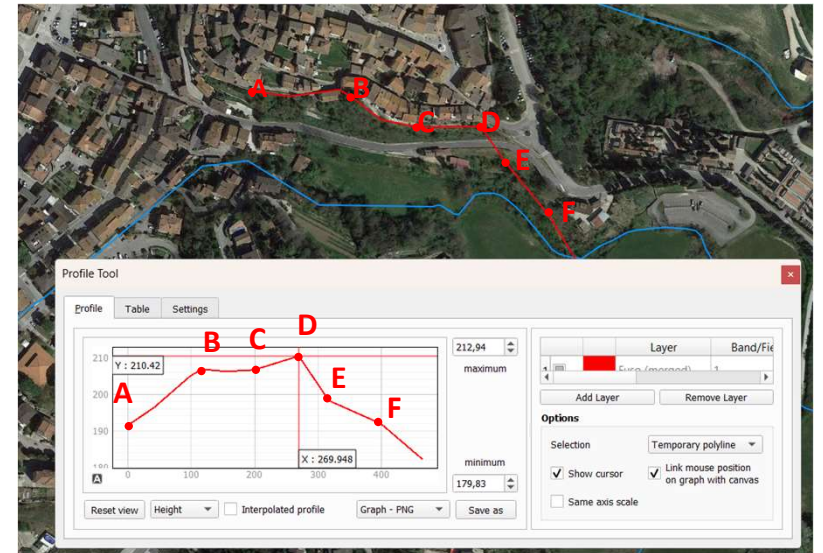
### Diagram:

**Management of Surface and Subsurface Waters.** The proposed interventions include regulating the waters of the slope through the rationalization, restoration, or correction of the existing sewerage network and drainage systems. The proposal outlines the potential path of the drainage system through underground channels, identified based on local morphological and slope characteristics. These waters will be directed towards four main collectors located along natural convergences on the southern slope of the historic center of Deruta. Through inspection and collection chambers, the waters will then be channeled into manholes beneath the road, leading to the final recipient, namely the watercourse known as "Fosso del Piscinello."
